# **A BROAD LEVEL CLASSIFICATION SYSTEM FOR DAM REMOVALS**

**Laura Wildman, P.E., Ecological Restoration Engineer, Princeton Hydro, LLC, New England Regional Office, 20 Bayberry Road, Glastonbury, CT 06033, 860-652-8911, lwildman@princetonhydro.com**

**James MacBroom, P.E., Vice President, Milone & MacBroom Inc, 99 Realty Drive, Cheshire, CT 06410, 203-271-1773, jimm@miloneandmacbroom.com**

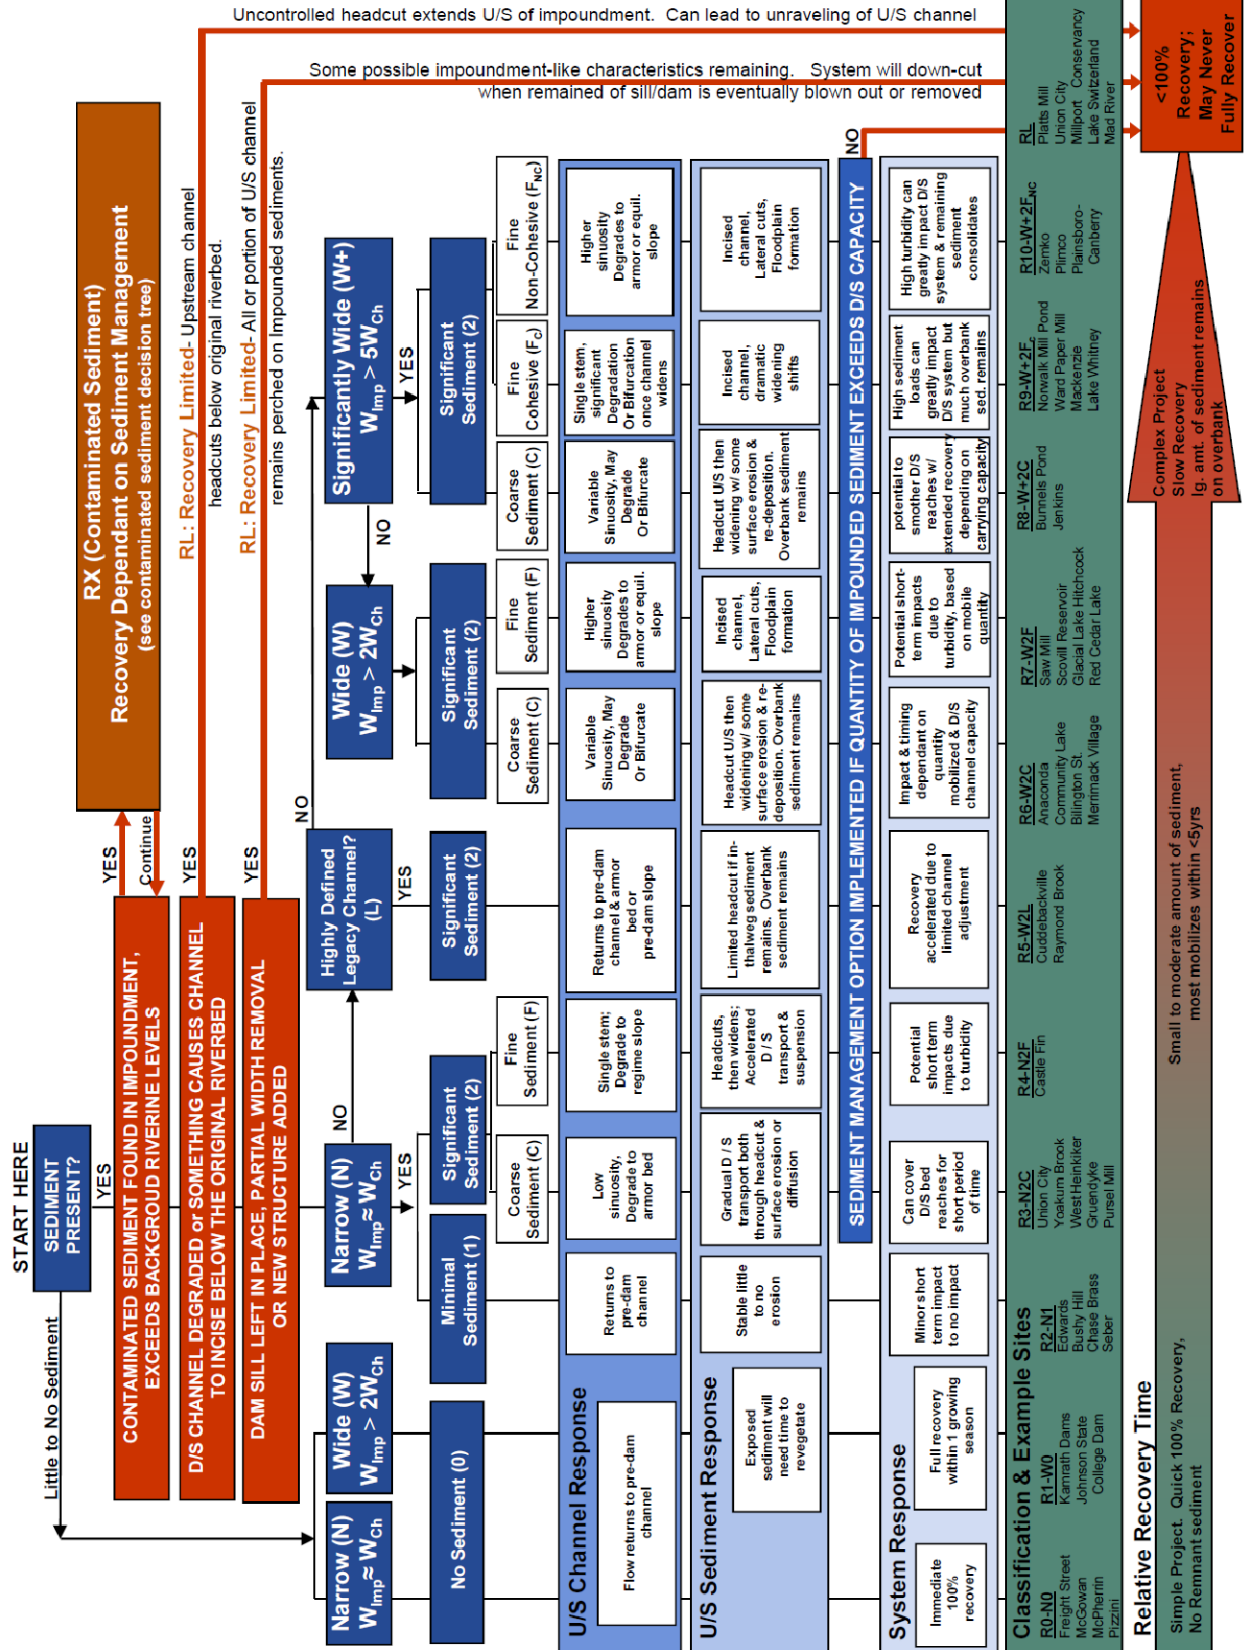
Figure 1: Dam Removal Classification System

- **R0:N0**: Narrow, No Sediment
- **R1:W0**: Wide, No Sediment
- **R2:N1**: Narrow, Min Sediment
- **R3:N2C** and **R4:N2F**: Narrow, Significant Sediment (coarse or fine sediment)
- **R5:W2L**: Wide, Significant Sediment, Legacy Channel
- **R6:W2C** and **R7:WCF**: Wide, Significant Sediment (coarse or fine sediment)
- **R8:W+2C**: Significantly Wide, Significant Sediment (coarse)
- **R9:W+FC** and **R10:W+2F<sub>NC</sub>**: Significantly Wide, Significant Sediment (fine sediment, cohesive or non-cohesive)
- **RL**: Dam Sill or Portion of Dam Left In Place; Structure(s) Added (recovery limited); or Channel Degraded or Degrades Below Original Pre-dam Riverbed
- **RX**: Sediment contaminated; system recovery dependant on sediment management option selected

Each dam removal project is identified by a relative recovery rate and a 2 or 3 digit descriptive code. The first digit describes the impoundment width; with N representing a narrow impoundment, W representing a wide impoundment (>2 times the channel width,) and W+ representing a significantly wide impoundment (>5 times the

channel width). The second digit describes the relative quantity of sediment; 0 represents a dam where no impounded sediment is present, 1 represents a dam where little impounded sediment is present, and 2 represents a dam where a significant amount of impounded sediment is present, such that further analysis is needed even if the sediment is clean. The third digit describes the characteristics of the sediment, F represents fine grained sediment (which is further divided in to  $F_C$  and  $F_{NC}$  to differentiate between fine grained cohesive sediment and fine grained non-cohesive sediment, respectively), C represents coarse grained sediment, and L represents the existence of a legacy channel.

<u>2 or 3 Digit Descriptive Code</u>		
<u>Relative Recovery Rate</u>	–	<u>1<sup>st</sup> digit</u>	<u>2<sup>nd</sup> digit</u>	<u>3<sup>rd</sup> digit</u>
R1 through R10, RL, or RX	–	N, W or W+	0, 1, or 2	F, $F_C$ , $F_{NC}$ , C, or L

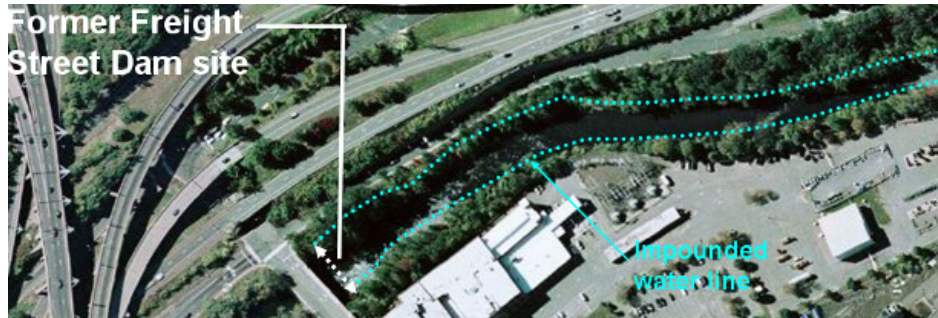
Figure 2. Freight Street Dam site 10 years post removal

Freight Street Dam: Classified as an **R0-N0** dam removal.

The Freight Street Dam was constructed in the 1950's on the Naugatuck River in Connecticut, but was never utilized. The dam was approximately 4 feet high and 100 foot long, constructed of concrete reinforced with steel sheetpile within the core of the dam. The dam was fully removed in October 1999.

There was little to no sediment impounded behind the Freight Street Dam, and during the dam removal, the site was excavated an additional 3 feet so that the crushed concrete from the dam could be disposed of on site. The crushed concrete fill was then topped with large rounded cobbles, typical of the river bed both upstream and downstream of the dam. The impoundment was minimal due to the low head of the dam and the fact that the channel width above and below the dam were consistent throughout this reach of the river. Ten years later the site appeared much as it did the day the dam was fully removed. No sediment appeared readily mobile either above or below the dam, and, if it were not for the west abutment that was left in place, most observers would never guess that there had been a dam at this site (Wildman et al. 2008).

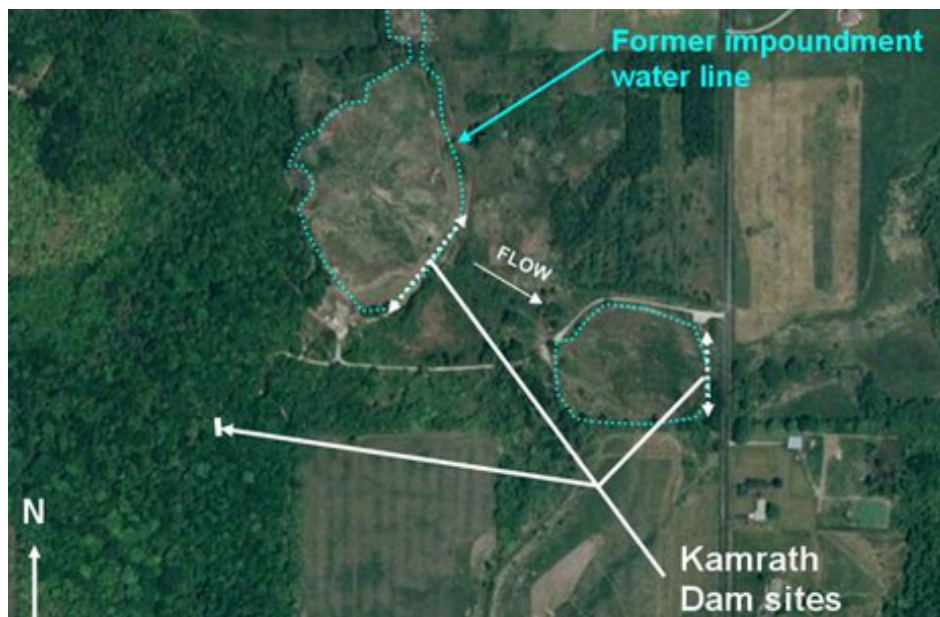
Figure 3. Kamrath Dams site 10 years post removal

Kamrath Dams: Classified as an **R1-W0** dam removal.

The Kamrath Dam removal project in Plymouth, Wisconsin, on Kamrath Creek consisted of the removal of two earthen dams and one concrete dam built around the 1950's. The impoundments created by the dams were used to rehabilitate horses and as a former fish hatchery operation. Each earthen dam was approximately 12 feet high. The concrete dam was approximately 5 feet in height and 15 feet in length. The demolition of the three dams was initiated in May 1999 and fully completed by July 2002.

Ten years after the initiation of dam removal there are no obvious signs of bank erosion within the former impoundments and the banks appeared to be very stable. The water clarity was excellent. There were also no signs of persistent deposition below the former dam sites. The site appeared to have fully stabilized (Wildman et al. 2008).

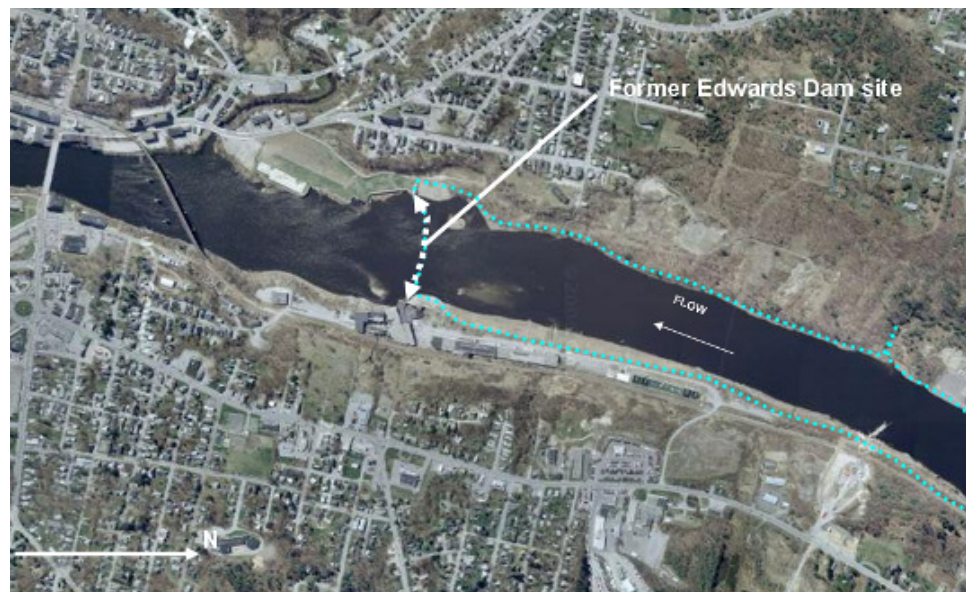
Figure 4. Edwards Dam site 10 years post removal

Edwards Dam: Classified as an **R2-N1** dam removal.

The Edwards Dam was a 24 foot high and 917 foot long dam extending across the width of the Kennebec River in Augusta Maine. The dam was built in 1837 to facilitate upstream navigation and provide mechanical power to a saw mill. The dam was a rock-filled timber crib structure with some concrete sections along its spillway. The dam was removed in two stages, using mechanical methods in July 1999 and August 1999.

There was very little impounded sediment above the Edwards Dam, likely due to the low profile of the dam in comparison to the width of the Kennebec River at the site. This low dam-height-to-channel-width ratio allowed for the scour and transport of the river's sediment load over the crest of the dam. In addition, there are several other dams upstream, also on the Kennebec River, that likely trap a portion of the sediment that would have reached the former Edwards Dam site.

The dam's impoundment was linear and extended upstream 17 miles. The width of the impoundment varied little from the width of the undammed reaches of the river. Therefore, when the dam was removed in 1999, the upstream channel width only reduced slightly, exposing a limited amount of the formerly submerged upstream channel banks. Ten years later, there were few visible signs of bank erosion within the former 17 mile impoundment. However, directly upstream of the former dam site, there were sections where undercut river banks and sand sediment bars were still evident along the eastern side of the riverbed during periods of lower flow. Signs of dam removal within the former upper impounded reach were minimal. There were no signs of large sediment deposits or islands created below the dam site, and it is likely that the majority of course grained sediment transported downstream through the system and out to the ocean (Wildman et al. 2008).

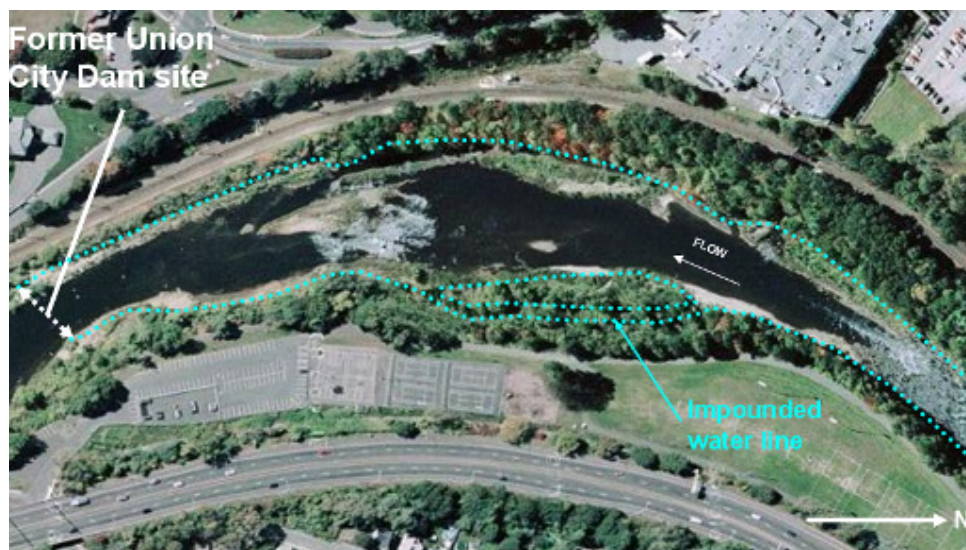
Figure 5. Union City Dam site 10 years post removal

Union City Dam: Classified as an **R3-N2C** dam removal.

The Union City Dam on the Naugatuck River in Naugatuck, Connecticut, was a 7 foot high, 190 foot long timber crib and rock fill dam, capped with grouted riprap. The dam was initially an abandoned industrial dam in poor condition, abutting Linden Park. The full width of the Union City Dam was removed in October 1999 by mechanical methods.

A portion of the impounded sediment was removed from behind the Union City dam prior to dam removal. However, the remainder of the impounded sediment was allowed to be transported downstream. Little evidence remains of the course grained deposits that were evident downstream of the dam directly after its removal.

The Union City Dam removal project was unique in the fact that, when the dam was removed and the headcut propagated upstream, it encountered a previously unknown and unused pipe encased in riprap that traversed the width of the river. This obstruction created a hydraulic jump that spread the width of the impoundment and created excessive bed degradation below the elevation of the original channel bed. It also temporarily stalled the headcut in this location and created a secondary headcut that then migrated upstream below the elevation of the pre-dam channel bed. This condition was still evident after ten years. The stalled headcut location had become a riffle approximately mid way up the former impoundment length. A deep pool persisted just below the riffle. Large sections of the pipe were fully exposed and dislodged from their channel bed location. The secondary headcut migrated the length of the impoundment and was in the same location it was three years after the removal. However, the grade change in this location was no longer dramatic and the headcut appeared stable, as a steep gradient cobble riffle. The channel bed upstream of the former impoundment was comprised of imbedded cobbles and therefore further progression of the uppermost headcut would likely only occur under significantly high follow events.

Although we have classified the Union City Dam removal an R3, it also has characteristics of a category RL dam removal, due to the down cutting of the channel below the original pre-dam riverbed grade and the slowly progressing headcut, created by the exposure of the riprap encased pipe that traversed the entire channel width (Wildman et al. 2008).

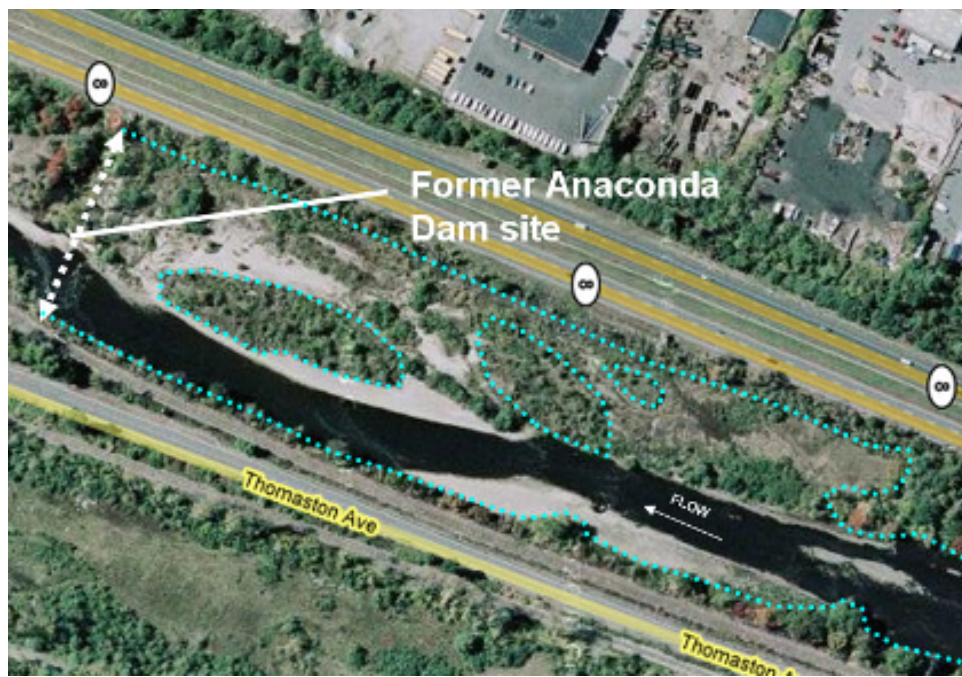
Figure 6. Anaconda Dam site 10 years post removal

Anaconda Dam: Classified as an **R6-W2C** dam removal.

The Anaconda Dam was a 330 foot long dam located in Waterbury, Connecticut along the Naugatuck River, consisting of a 137 foot long, 10 foot high timber crib spillway and a 190 foot long, 11 foot high earthen and rock fill embankment reinforced with steel sheetpile. The dam was initially built prior to the 1900's as a farm pond. It was later converted for industrial water diversion use by the Waterbury Brass Company. The timber crib portion of the dam partially breached during a storm prior to the dam's scheduled removal, allowing the majority of the mobile impounded sediment to move down through the river system, and undermining an active sewage pipeline. The timber crib spillway was then fully shortly after the initial breach in February 1999. The remaining 190 foot long earthen and rock filled portion of the dam still remains in place.

Ten years post removal there were still obvious signs of bank erosion along the western bank of the channel upstream of the former dam site. However, this undercut bank appeared much as it did during a 2003 site visit, and the bank seems to have reached a semi-equilibrium state, even though it was not vegetated down to the water level.

The eastern bank of the upstream channel had continued to aggrade since the 2003 observations, with new sand and gravel deposits from upstream, on top of what was initially an undercut bank directly after removal.

Due to the wide nature of the former impoundment much of the impounded sediment remained on site and was stabilized by vegetation on the far western side of what was once a string of vegetated islands in the center of the former impoundment. These islands were created by the coarse grained sediment delta that formed behind the Anaconda Dam. The delta had progressed from the upstream end of the impoundment to the dam itself. The impounded sediment islands also remained intact upstream of the dam, although the former impoundment was only inundated, as a floodplain, under high flow conditions. Post-removal, a headcut migrated upstream and stalled approximately mid impoundment. A riffle formed in that location and the headcut then proceeded to the upper end of the former impoundment where it appeared relatively stable, ten years post removal. Large coarse grained sand and gravel bars, made up of former impounded sediment, still resided mid-channel and along the riverbanks downstream of the former dam site, and have dissipated little in the last 9 ½ years since the dam was removed (Wildman et al. 2008).

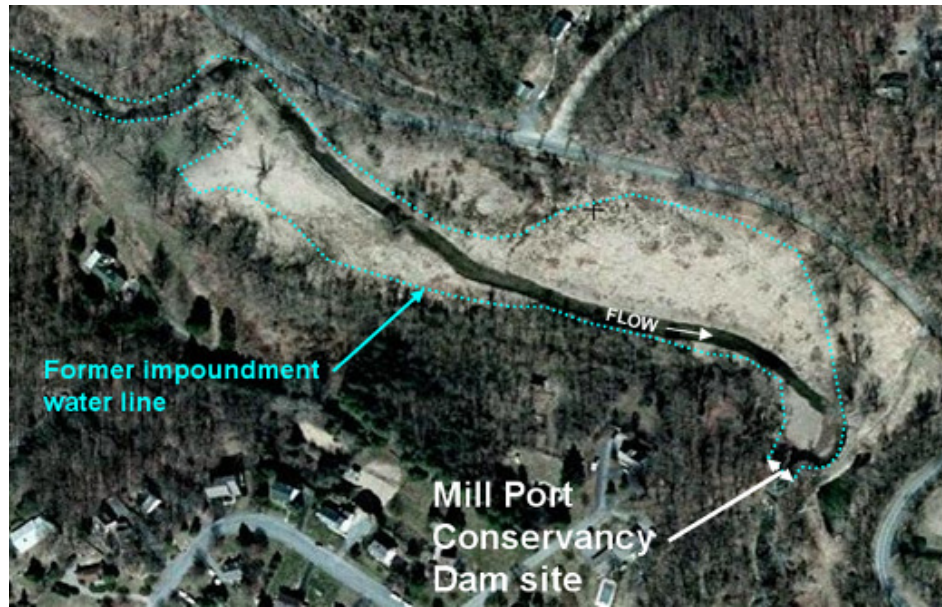
Figure 7. Mill Port Conservancy Dam site 10 years post removal

Mill Port Conservancy Dam: Classified as an **RL** dam removal.

The Millport Conservancy Dam, located near Millport, Lancaster County, Pennsylvania, was 10 feet in height and 50 feet in length. The spillway of the dam was removed in 1998 by mechanical methods with no sediment dredging or channel shaping proposed as part of the dam removal design. The earthen embankment of the dam remains as a separation between the new stream channel and three small ponds on an adjacent tributary.

The dam was breached in a different location from its likely original channel, causing, in effect, an approximately 3 foot high dam to remain in place. Therefore, much of the impounded sediment is still retained within the former impoundment site, and underlies the current channel bed. The site shows no significant signs of continued down-cutting and head-cutting and is now heavily vegetated. However, if the remaining portion of the dam were to ever breach naturally, the site would likely go through another period of transition and down cutting before it reached its original channel bed elevation. Ten years post removal, the site retained many characteristics of an impounded channel. Some coarser grained material appeared to be depositing on top of the finer grained underlying impounded sediment that still remained within the channel bed. There were some undercut banks, but, otherwise, banks were generally incised with dense herbaceous vegetation along them (Wildman et al. 2008).
